Use of Façadism in Divided-Walled Nicosia, Cyprus

Christina Pieri

School of Architecture, Design & the Built Environment,
Nottingham Trent University, U.K.
christina.pieri2007@my.ntu.ac.uk

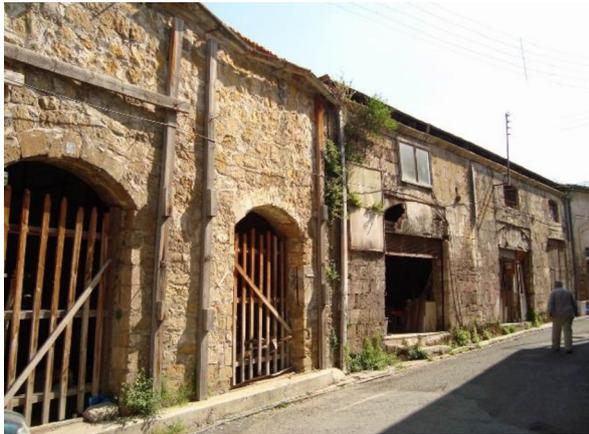
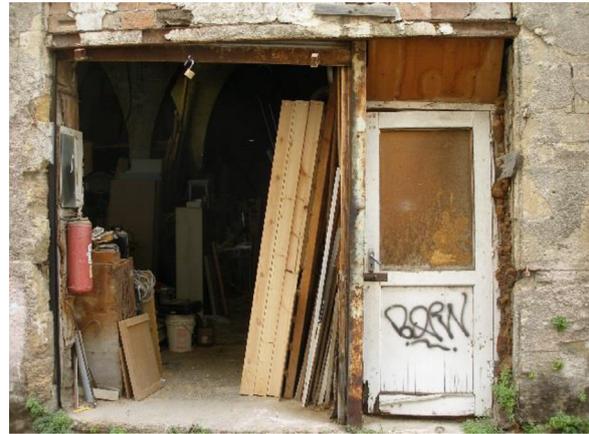
Figure 2: Dionisou Street before its rehabilitation by the NMP Source: Nicosia Master Plan office (2014a).

Figure 3: (bottom) Dionisou Street before its rehabilitation by the NMP Source: Nicosia Master Plan office (2014a).

A prominent example that demonstrates this approach is the one of Dionisou Street. This area primarily consists of workshops and residential buildings. Nevertheless, its proximity to the buffer zone, along with the gradual departure of long-term tenants from the area had resulted in the decay of its authentic fabric and vocational character.

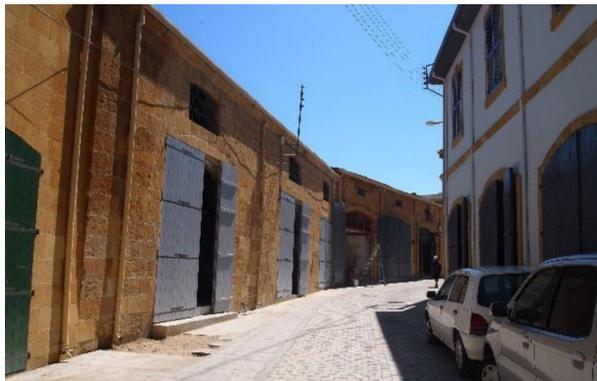
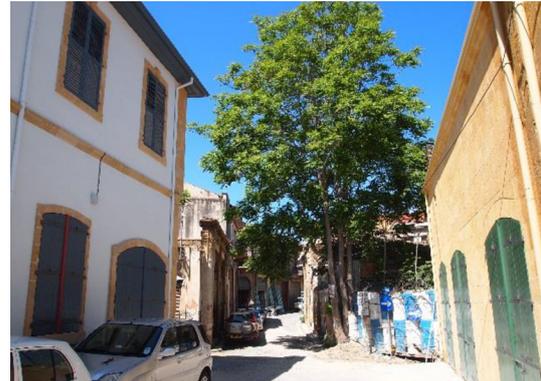
Figure 4: Restored facades at Dionisou street Source: Nicosia Master Plan Office (2014b)

Figure 5: Restored facades at Dionisou street Source: Nicosia Master Plan Office (2014b)

Following its restoration, and despite the fact that the functionality of the area has not been completely reinstated, the NMP's goal of 'gluing' the historic city back together has visibly altered the appearance of the specific street. Nonetheless, even though the buildings have been made structurally safe before being restored, the NMP's focus was on the aesthetic upgrading of buildings, primarily through façade restorations, rather than repairing their entire structures.

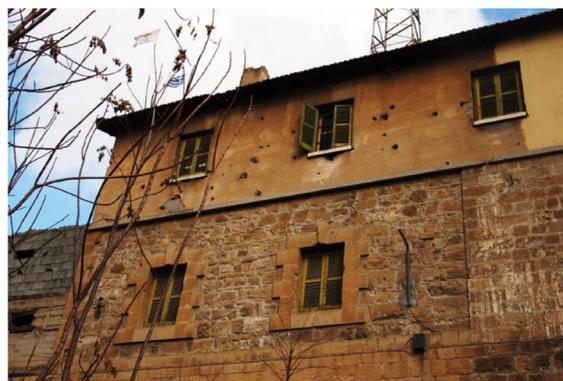
Figure 7: Governmental building (police station) next to the vehicular access and above the pedestrian access of Paphos gate. As can be observed, attempts to paint the façade (see right of picture) have been made. However, all regeneration attempts avoid the concealment of the existing bullet markings. Source: Author (2014).

An example that highlights this finding is that of the Paphos Gate area , where bullet holes and other conflict-related damage on the fabric of buildings over the walls has been preserved, despite restoration initiatives on the adjacent buildings (Figure 7 - Figure 9).

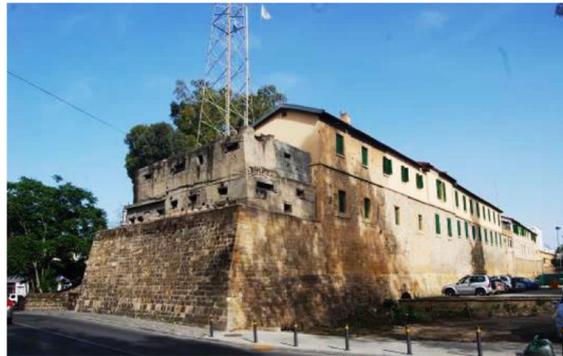
Figure 8: Vehicular access to walled Nicosia from the Paphos Gate Source: Unknown (2016).

The illustrated area of Paphos Gate is of particular tangible and intangible heritage significance to the Greek Cypriot and Turkish Cypriot communities of Cyprus, as it is one of the first and main access points to the walled city associated with commerce, surveillance and religious activities within the walls (Oswald, 2013). More specifically, Paphos Gate is one of the main entrances to the walled city that includes Venetian, Ottoman and British colonial buildings. The gate has always been a strategic position since the Ottoman and British times, and continues to function as a surveillance point under the Greek Cypriot Government, with the existence of a police station just above the pedestrian part of the gate (Figure 8). In addition, the area is associated with inter-communal riots commencing during the EOKA struggle and the Greek Cypriot - Turkish Cypriot struggle, “[which] resulted in the security forces erecting a barbed-wire fence along Paphos and Hermes Streets from the Paphos Gate to the Famagusta Gate” (Oswald, 2013). As a result, the memories associated with the Gate go beyond the tangible built environment and recall significant aspects of the Greek Cypriot - Turkish Cypriot conflict.

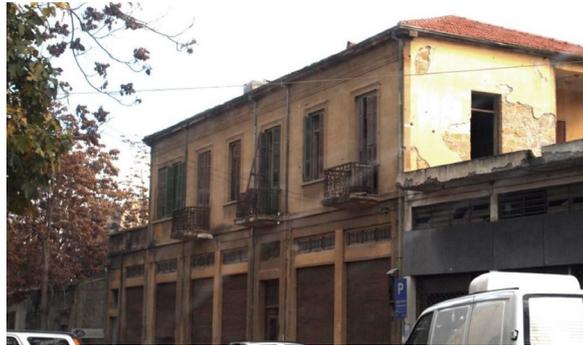
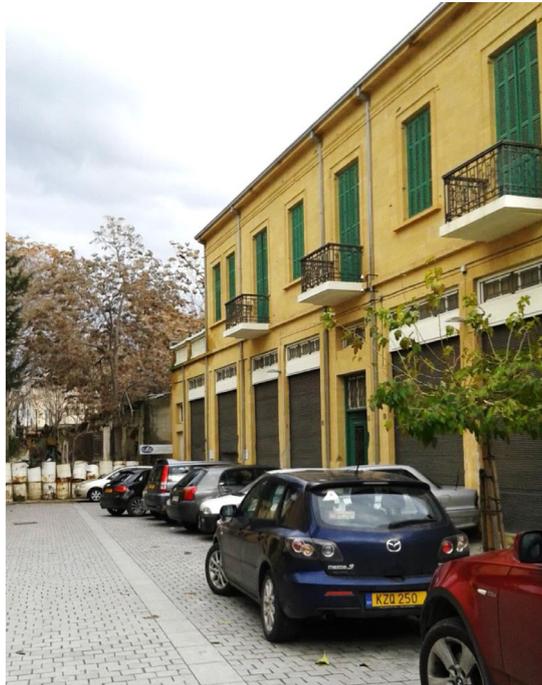
Figure 10: Façades on Paphos Street before restoration, walled Nicosia

Figure 11: Recently restored building facades on Paphos Street, walled Nicosia Source: Author (2017).

Figure 10 and Figure 11 demonstrate that on Paphos Street, buildings next to the buffer zone have been restored following a similar approach to that used on Dionisou Street. In both cases, the use of façadism is visible as a key strategy for the beautification of decaying buildings and neighbourhoods. However, the example of Paphos Gate suggests of a disparity between the treatment of the buffer zone boundary, when compared to parts of the Venetian walls that have been influenced by conflict. The management of heritage in this case, differs from one area to the other, with traces of conflict being selectively preserved throughout the walled city. This phenomenon is mainly visible in the south-west part of Nicosia and closer to the buffer zone area; due to the increased number of projects undertaken by the NMP in the Greek Cypriot part of the walls.
